December 5, 2018

Brooks Academy Museum Report

Exterior Assessment & Concept Design Study

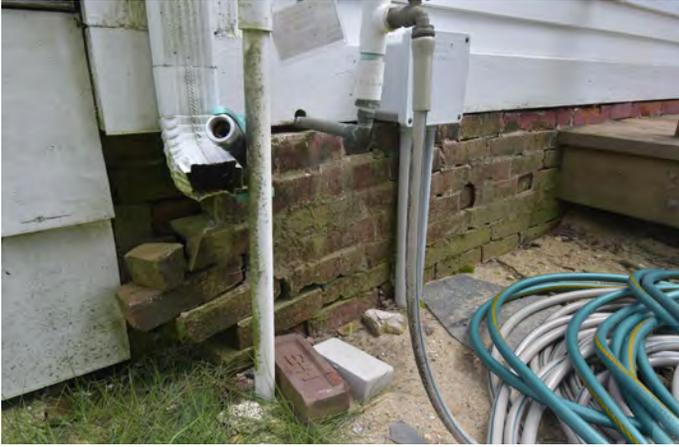
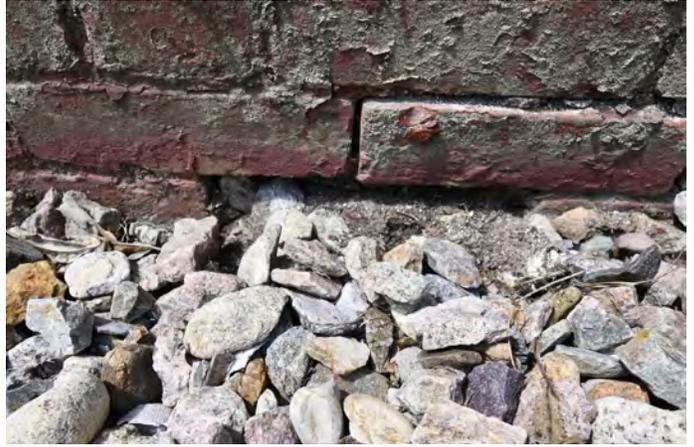
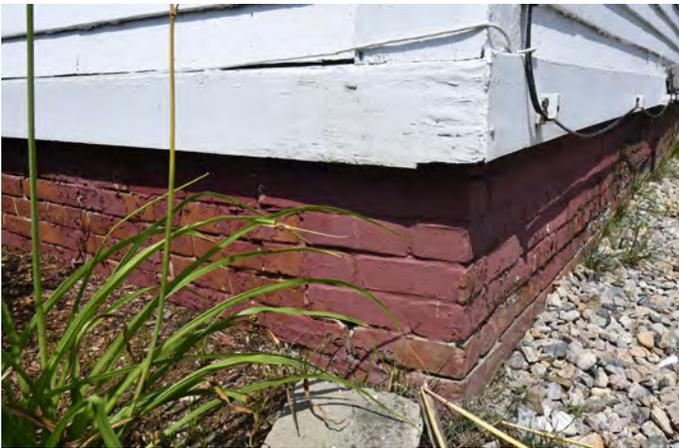
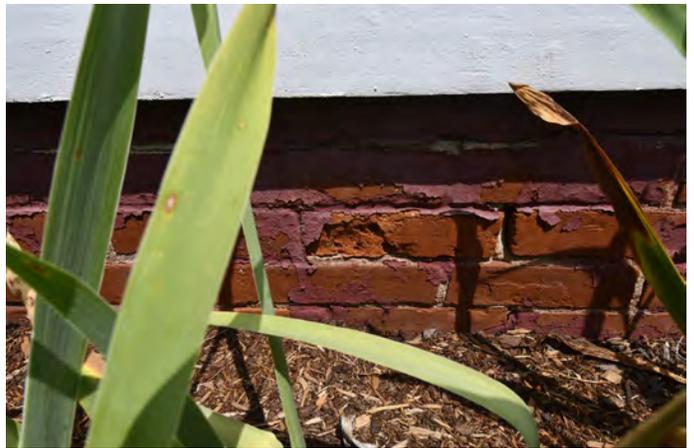
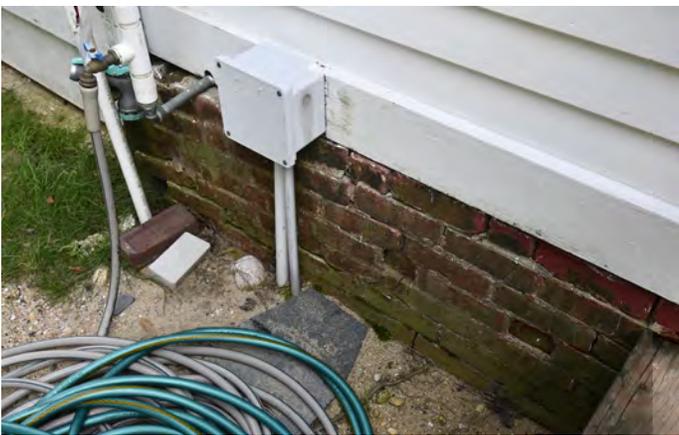
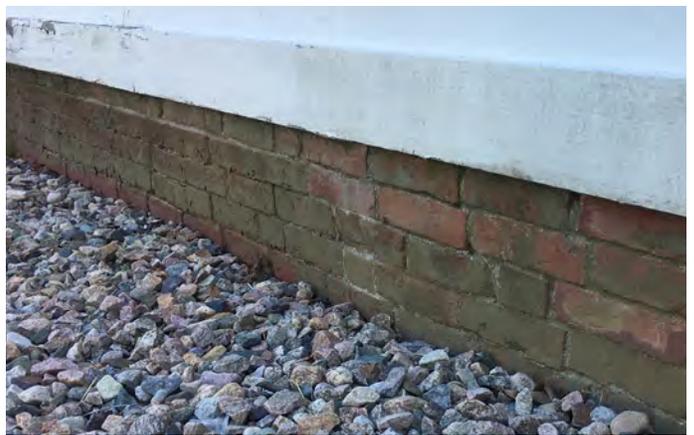
Existing foundations are common red brick, laid in a running bond pattern. We observed a compromised foundation wall along the east side of the main building where water from the roof appears to cascade down to a gravel bed along the foundation wall. This allows water to splash back up on the wall, causing joint deterioration. This wall is visibly stained with dirt and hosts an algae coat. The brick is also painted which acts to trap moisture in the bricks, further jeopardizing the integrity of the material.

At the south east corner of the building the foundation wall has settled slightly, and at the northwestern corner of the portico, foundation bricks have fallen away and the foundation is no longer supporting this corner of the building.

During rainstorms water can be seen to cascade directly down from the disconnected downspout at the gutter. This deluge of water is likely responsible for the deterioration of this brick foundation corner.

Rainwater damage caused by water falling directly from the Main Building roof eave, or through downspouts that deposit gutter runoff directly against the building, needs to be corrected so that rain water is either collected or directed away from the building's foundations (see gutter and downspout section following for details).

Once the roof rainwater runoff problems are resolved, the foundations need to have paint coatings removed, brick repaired where damaged, and repointed throughout.

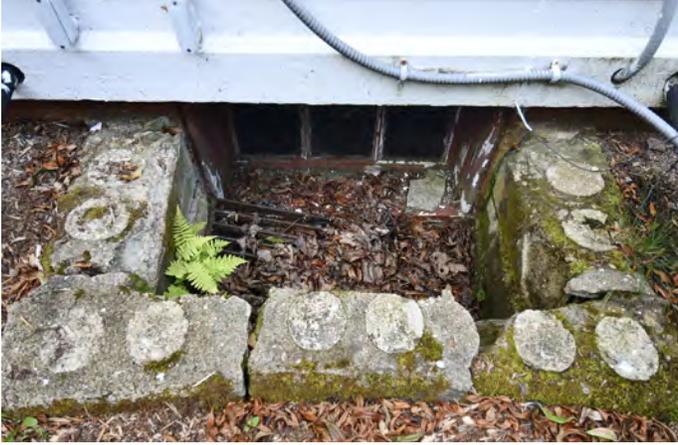
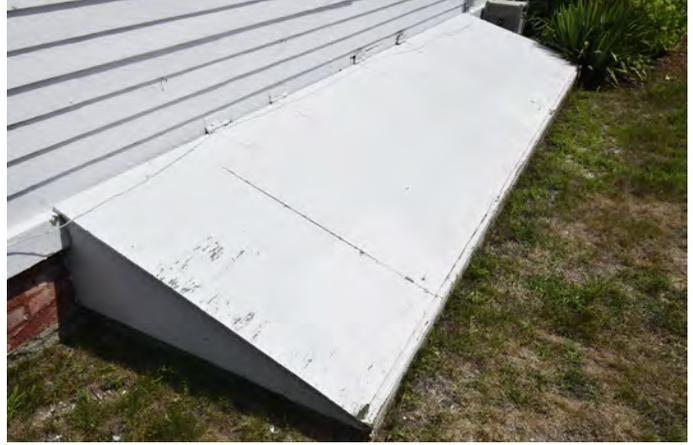
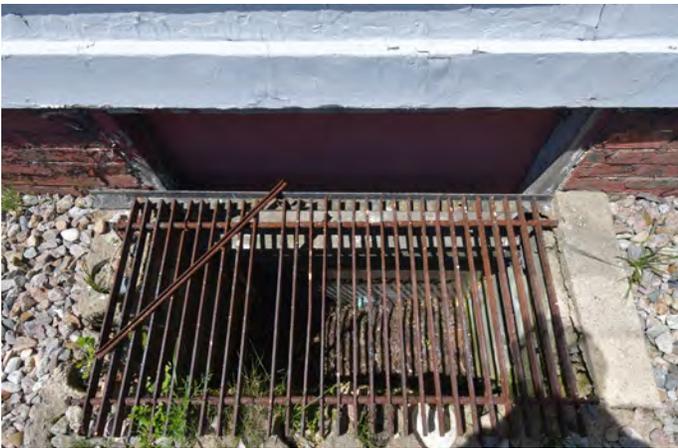
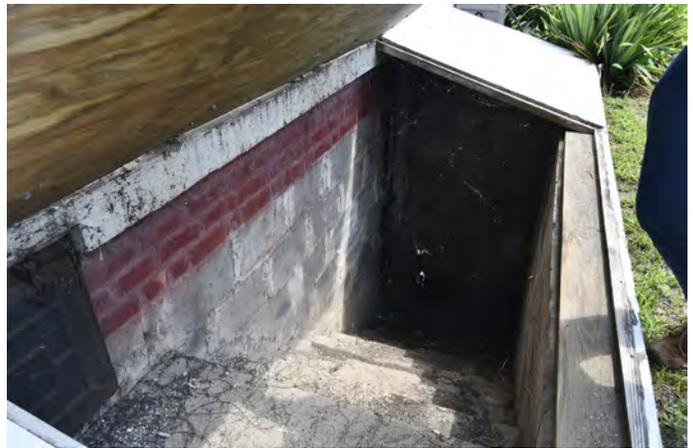
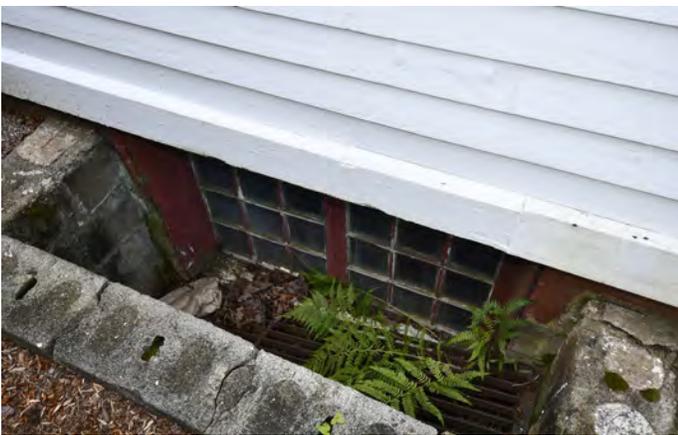
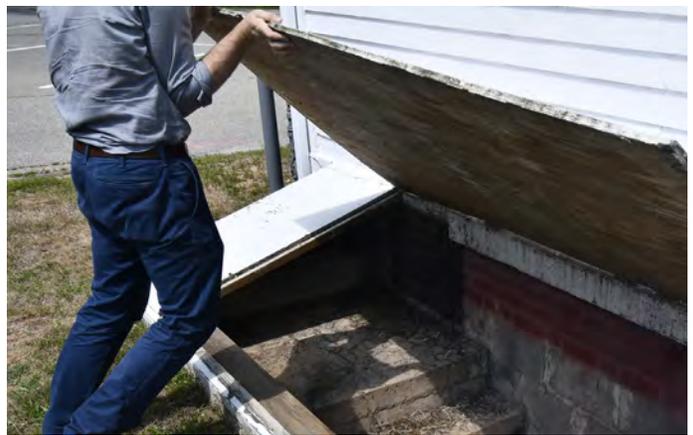
Main Building: Two areaway wells are located on east side of Main Building providing fresh air access to mechanical room 2. From inside mechanical room 2 there is evidence of standing water which is likely gaining entry through the areaway opening in the foundation wall that lack weathertight louvers or closure panels. There are other problems associated with mechanical room 2 and the supply shafts that rise from it along the east side of the Main Building which are discussed later in this report. The water penetration at this location needs to be analyzed in further detail and remedied before further damage occurs.

Annex: Eight areaway wells are located on the south, west and north sides of the Annex. The 1999 ACA advised that these masonry wells were crumbling and filled with leaves and other debris. In our visual inspection these appear be concrete block are not crumbling, but vegetation and debris persists. We observed that gratings on the north side are in poor condition and have caved in. These same three wells also have fern plants growing in them.

Bulkhead door is comprised of a single sheet of painted plywood, hinged to the clapboard siding. The paint on the plywood is beginning to peel off. The interior of the bulkhead is in good condition and requires no attention at this time.

For areaways at the Annex, conduct a cleanout and inspection of each well to determine if repairs are warranted and if drainage is effective. Remove plants and debris. Repair or replace steel grates that are damaged or in poor state of repair.

Bulkhead door requires repainting. The accessway requires no repairs.

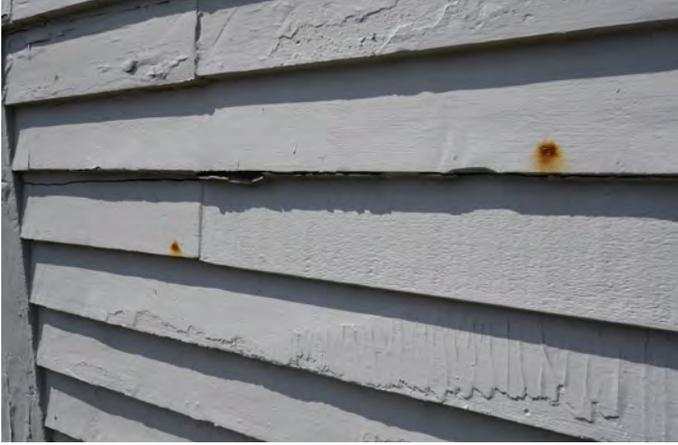
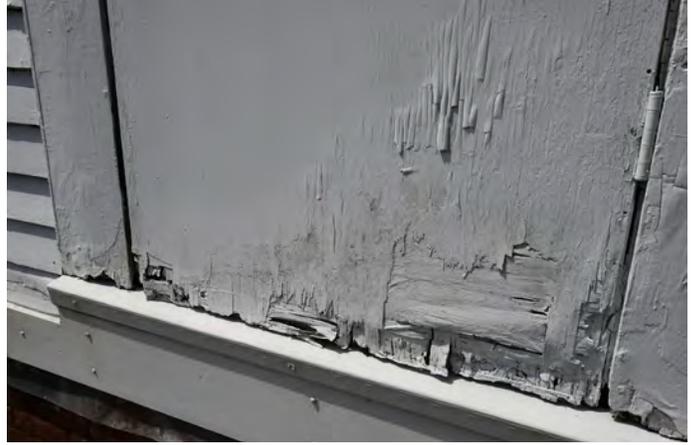
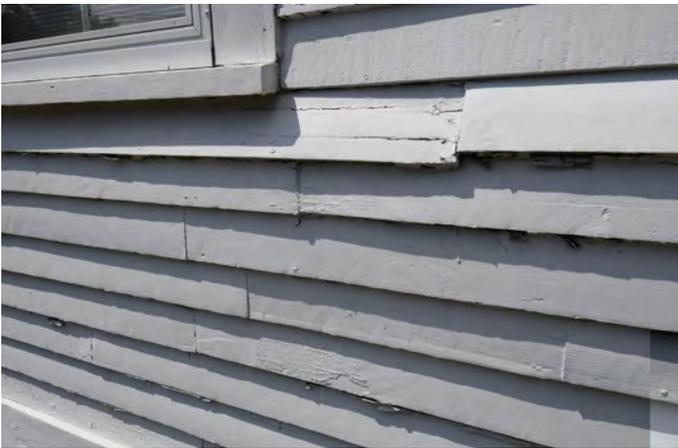
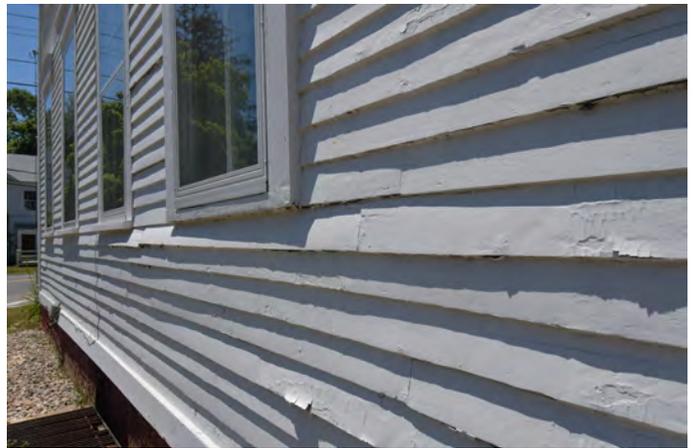
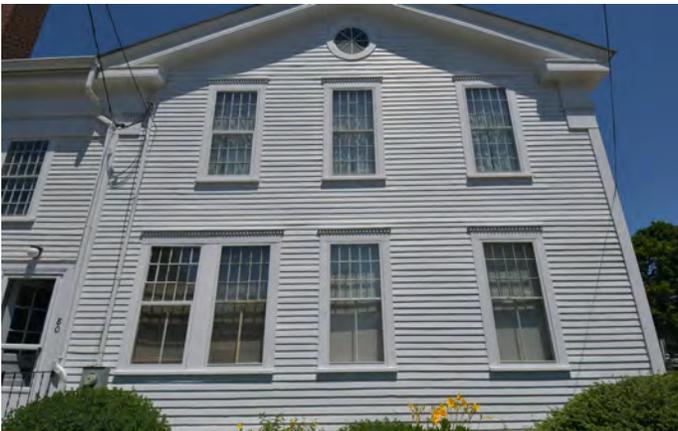
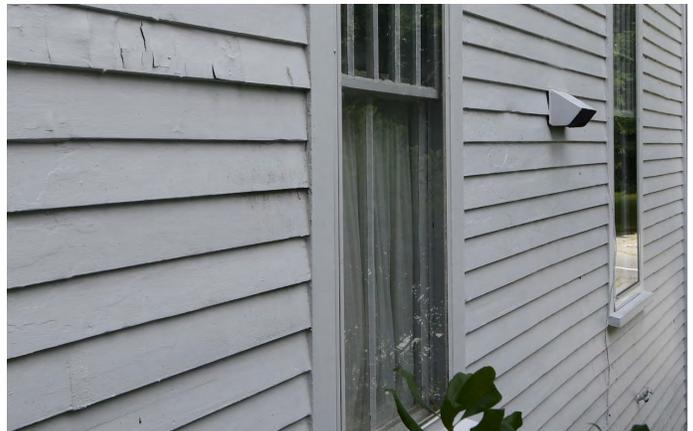
1. Paint on entire east side of Main Building is peeling, apparently due to rainwater runoff from the roof running down the face. With the exception of this side of the building, wood trim and clapboards appear to be in adequate physical condition for refinishing once dry.

2. A portion of the east side of the Main Building clapboards, between the third and fourth windows from the south, around sill height, are displaced outward. We believe that this may be the result of warm damp air rising in the interior heating duct shafts located on this wall (which may not be lined), migrating to the exterior by air pressure, and condensing on the inside surface of the clapboards. In sub-zero weather this would freeze and expand, causing the displacement we observe on the exterior. Without the ability to see inside these shafts it is not certain that this is the cause, but it seems likely given the wet conditions in mechanical room 2 and the general dampness of the basement crawlspace that this system is open to. This condition needs to be addressed promptly to avoid further deterioration.

1. East: large portions of this side of the Main Building are peeling and should be scraped and prepared for repainting. The areas where clapboards are bulging out should be investigated for causes and repaired as feasible. This may entail interior renovations to the heating duct shafts on this exterior wall

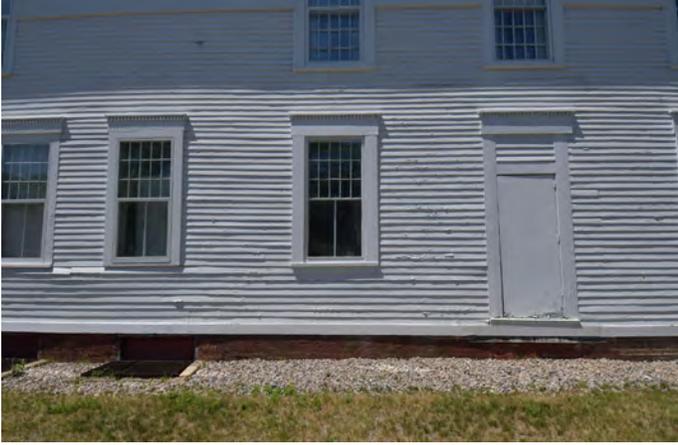
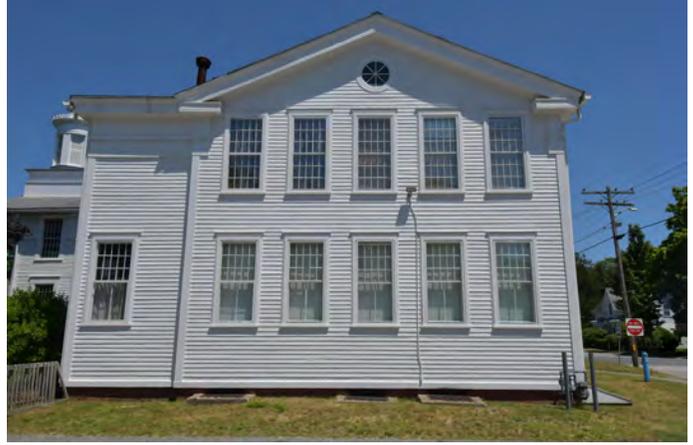
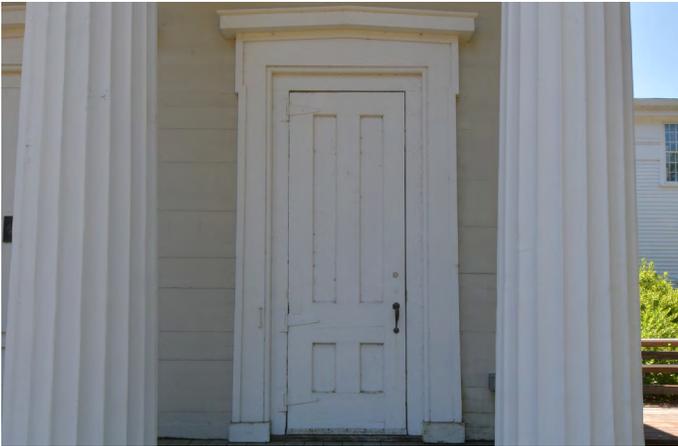
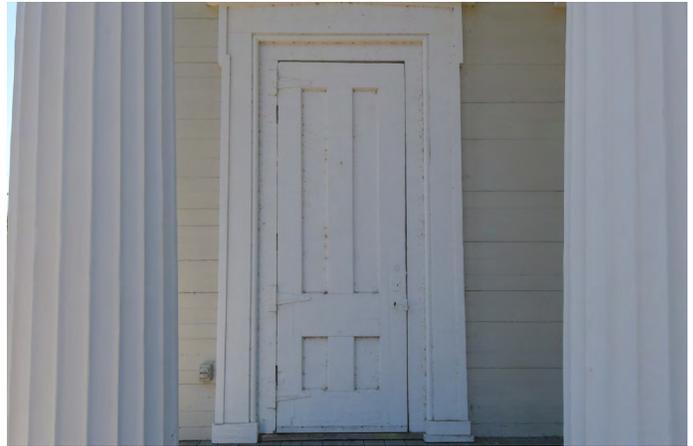
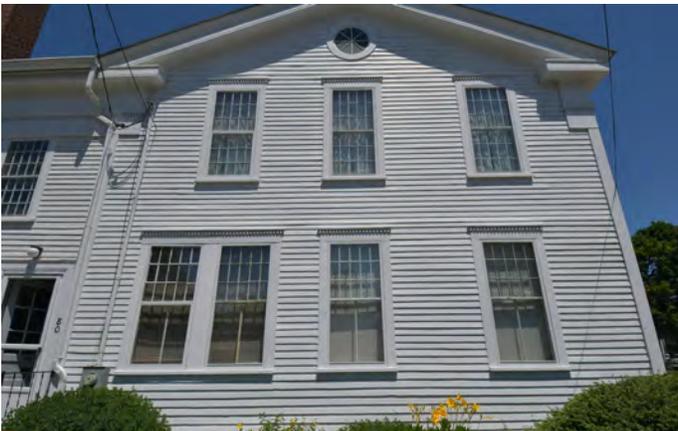
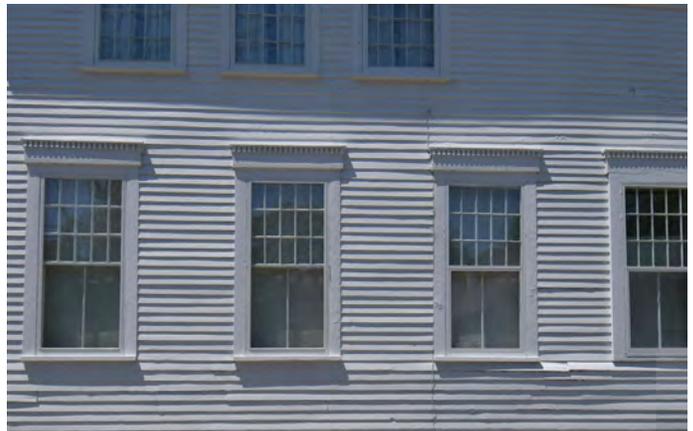
White painted aluminum storm windows cover double hung, painted wood single-pane windows. The wood window sash are observed to be in poor repair and in need of upgrades to improve operability and weatherproofing.

East: the front "Cranberry" room has a boarded up former emergency exit door that is no longer functional. The plywood panel that fills this location is in poor condition and detracts from the character of the exterior. There is also an oversized piece of metal flashing that projects out below the lower trim board that should be removed. The 1999 ACA states that this opening was not original and should be replaced with a window to match the others in this room.

Due to the historic significance of the structure it is advisable to repair the existing wood double hung windows; replace missing glazing putty, repaint, improve operability of sashes, and improve weather stripping.

East: we concur with the 1999 ACA recommendation of removing this door opening and replacing with a window unit identical to the others in this room. Extend clapboard siding beneath to complete the restoration.

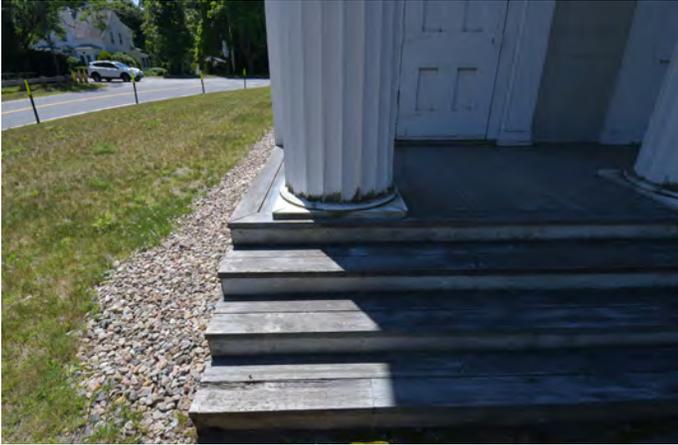
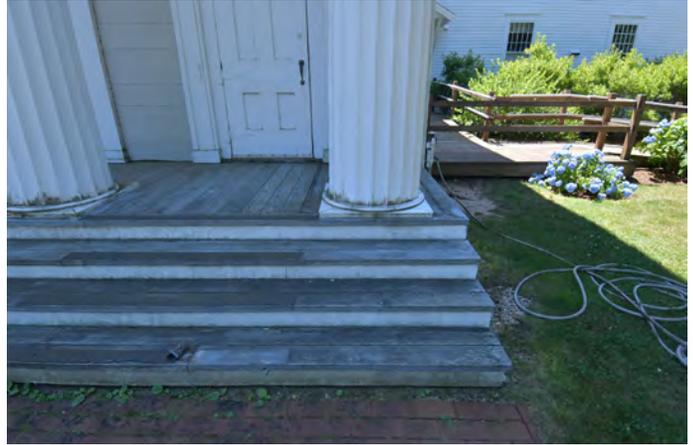
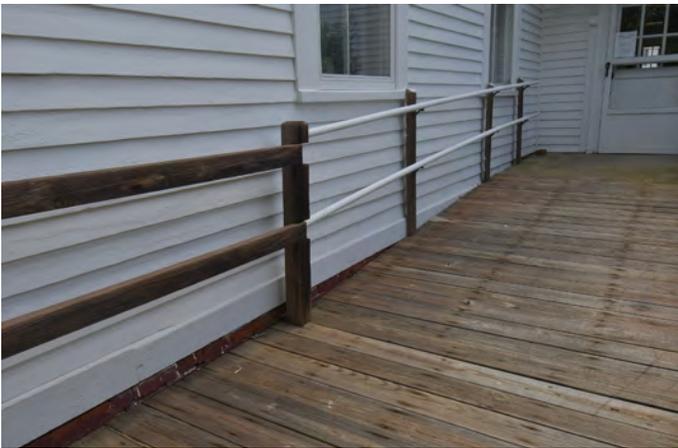
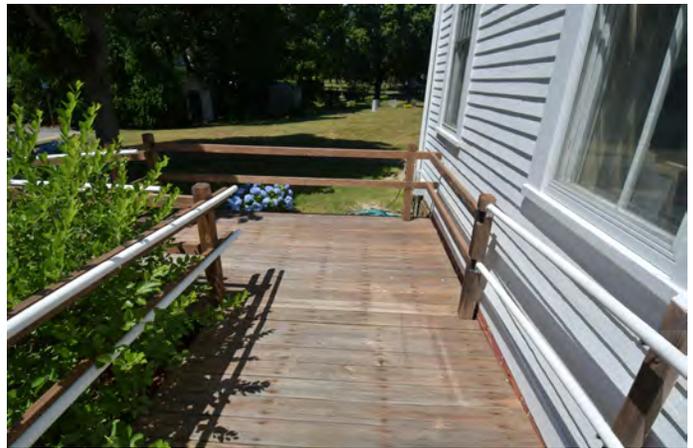
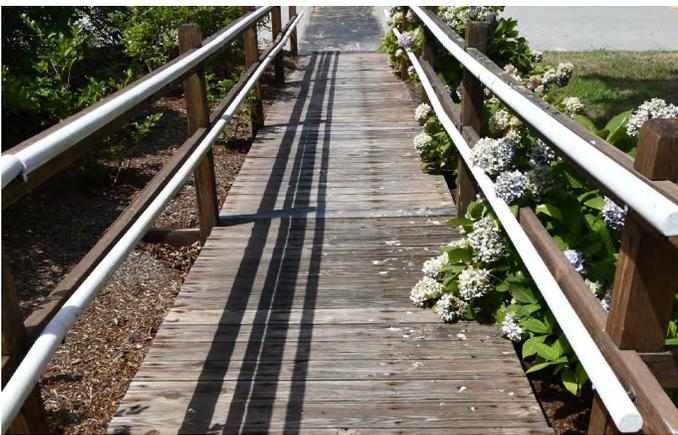
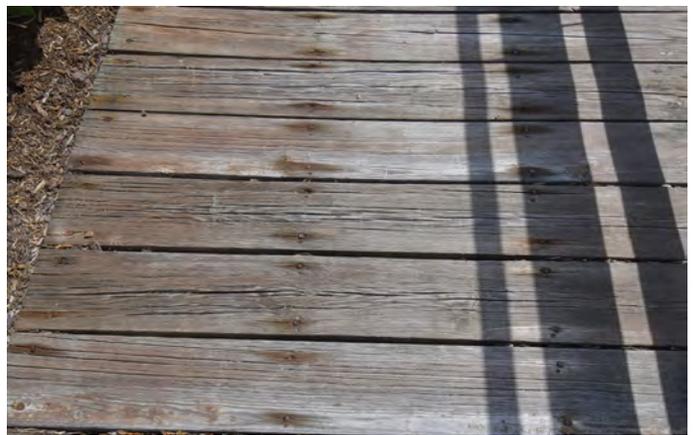
The porch and step treads are made of 5/4 fir planks, stained gray. Some areas of the steps exposed to rain and snow (falling from the roof above most likely) are disintegrating and need replacement, and the stain has largely worn off leaving a distressed appearance. The porch sides and step risers are clad with painted pine boards that extend almost to the ground. Due to exposure, the wood has become quite dirty and is in need refinishing.

1. Minimal improvements include replacement of damaged treads risers and refinishing of wood with gray stain and white paint.
2. If a new entrance is to be created, the porch and steps should be rebuilt approximately 2" higher to create an accessible entrance. The wood columns have a steel core and can remain in place with the porch built around as they are today.

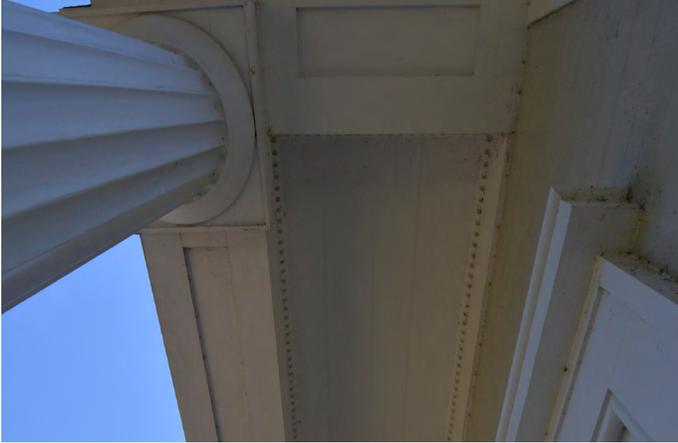
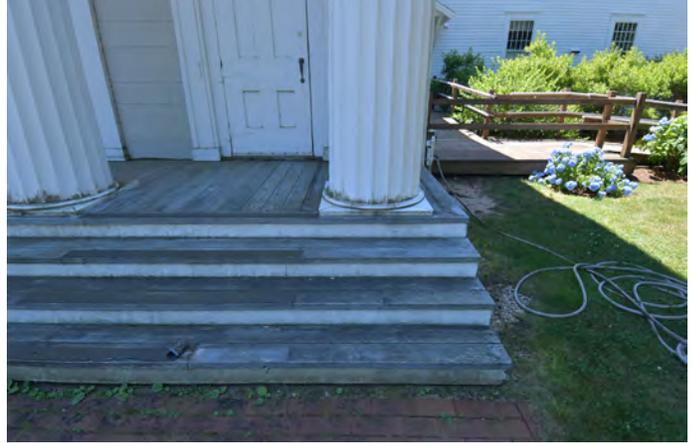
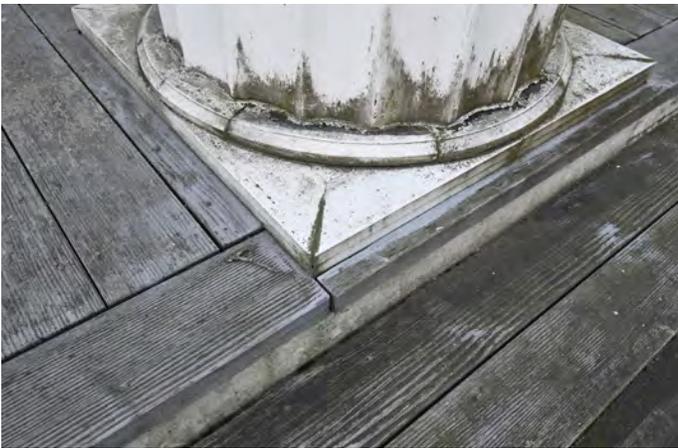
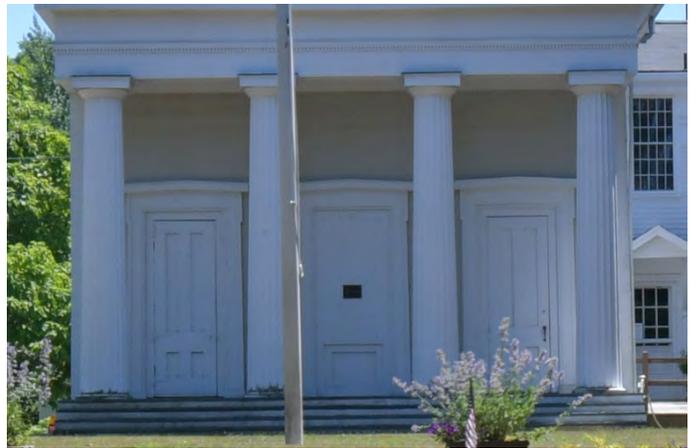
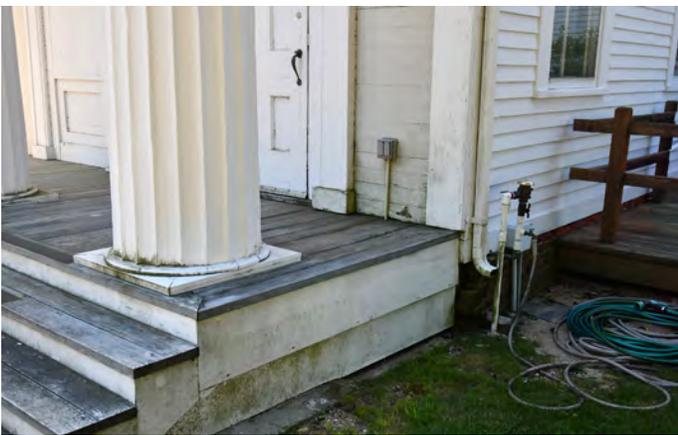
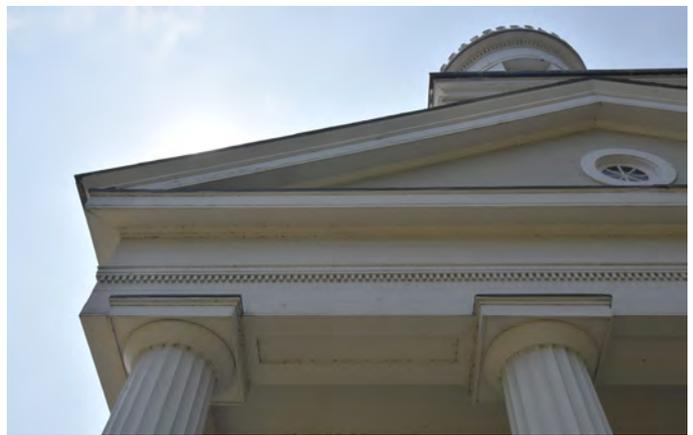
The 1999 ACA identified the need to replace all four fluted Doric wood columns across the front of the building due to water damage at their bases. Consistent with the Greek Doric Order upon which these are modeled, the columns originally (and up until 1999) rested directly on the wood deck "plinth." Sometime after 1999 the wood columns were removed and replaced with new replicas, set on new hybrid shaped wood bases (breaking with the Greek Doric order in order to functionally elevate the bottom of the wood columns above the deck to help minimize damage from standing water).

At the front portico, paint is observed peeling off of the raking cornices and the entablature (horizontal trim band above the columns). The tympanum and lunette appear to be in good condition. Flashing over the top of each column capital also appears to be functioning well and there is no sign of damage on the column capitals below.

Redesign the column bases to pitch away from the columns, minimizing the degree to which water can accumulate at the bottom of each column. Because this is all wood construction it is imperative that annual inspection and upkeep be conducted to prolong the life of these elements. Consideration may also be given to a custom carved stone bases as a way to improve durability and resistance to water damage.

Scrape, prepare and repaint sections of the raking cornices and entablature that require refinishing.

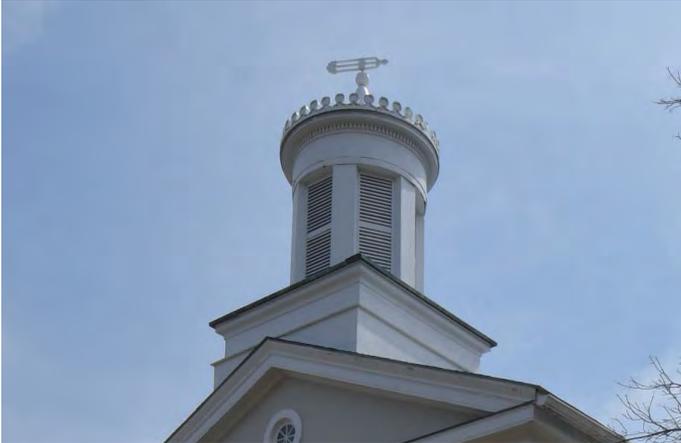
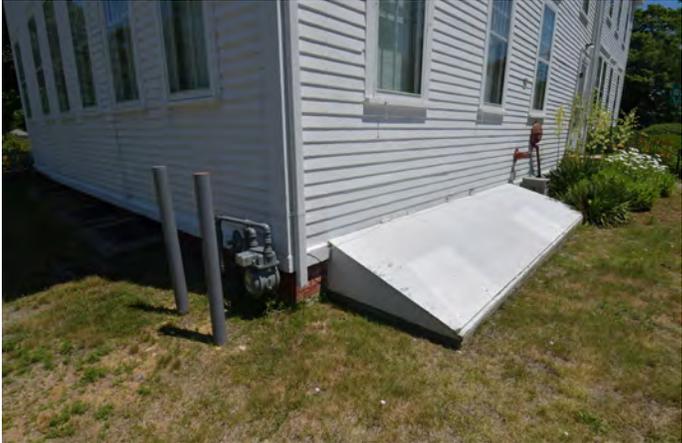
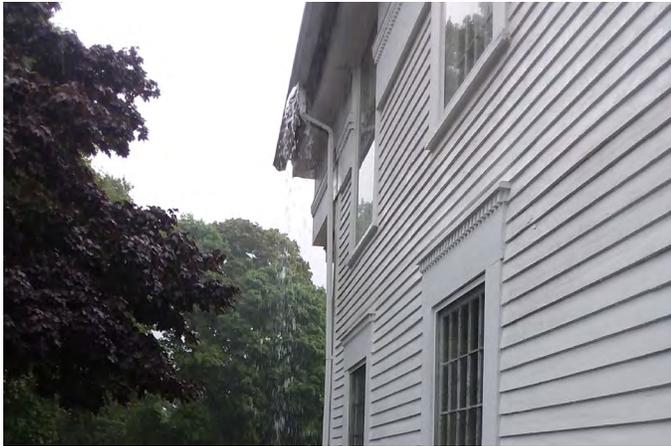
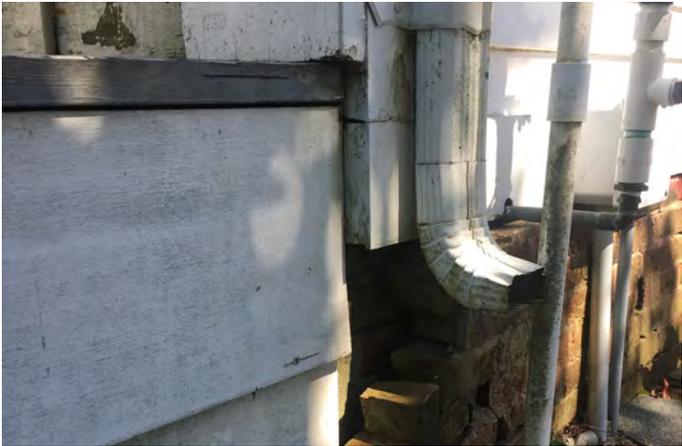
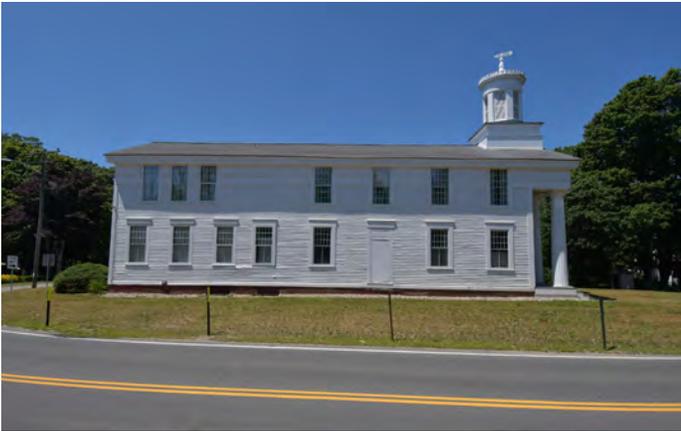
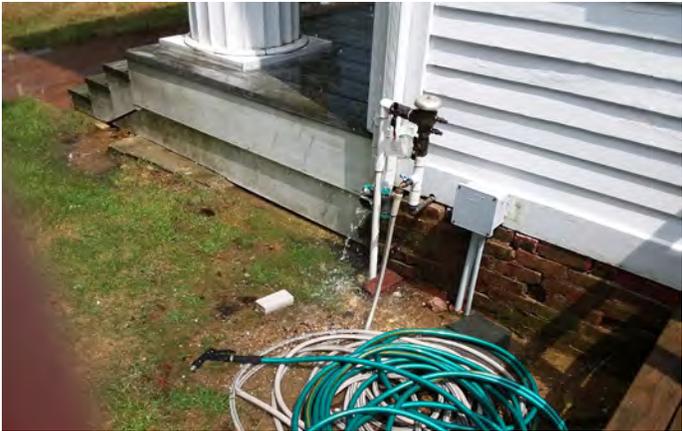
The cupola roofs have very small surface areas and appear from the ground to be in relatively good condition. While the components of the cupola show little sign of deterioration, paint is starting to peel in a few areas.

East: no gutter present, resulting in water damage to cladding and foundations

South: aluminum gutter across Annex front drains to two downspouts, each of which deposits water directly on the ground at the foundations.

West (Annex): no gutters - gable end sends water to either side; flat roof portion exhibits some signs of staining on the upper trim boards due to water breaking over this edge.

We concur with the recommendations of the 1999 ACA, and suggest replacing the entire system with copper gutters and downspouts connected to an underground perimeter collection pipe system.
