December 5, 2018

Brooks Academy Museum Report

Exterior Assessment & Concept Design Study

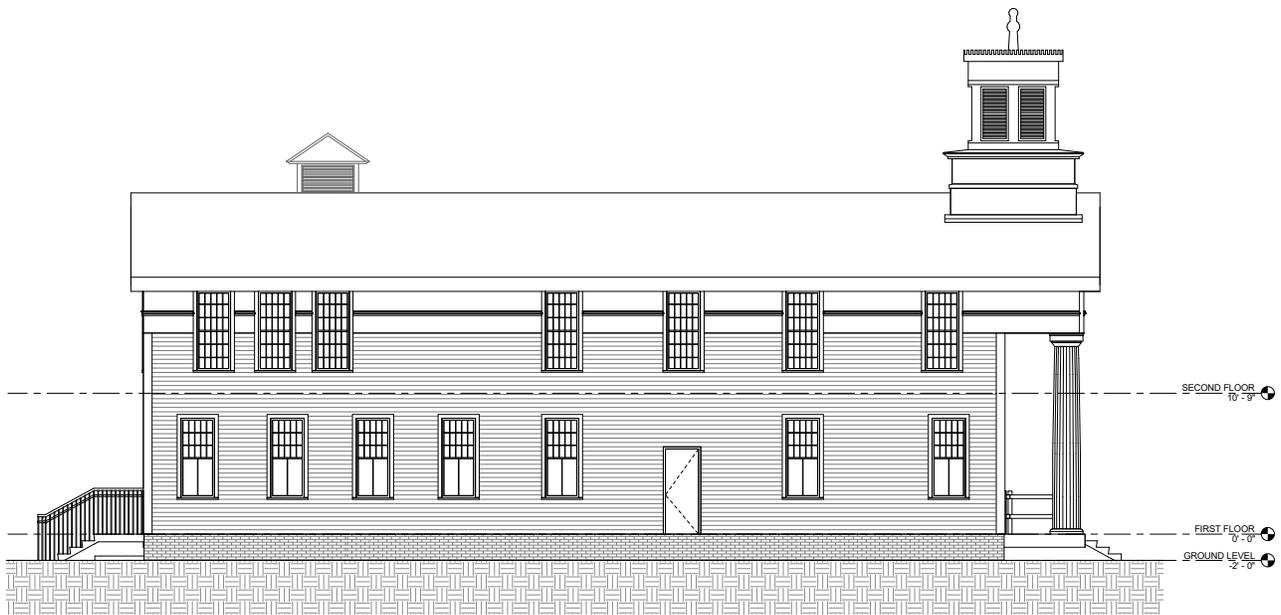
East Elevation

Existing foundations are common red brick, laid in a running bond pattern. We observed a compromised foundation wall along the east side of the main building where water from the roof appears to cascade down to a gravel bed along the foundation wall. This allows water to splash back up on the wall, causing joint deterioration. This wall is visibly stained with dirt and hosts an algae coat. The brick is also painted which acts to trap moisture in the bricks, further jeopardizing the integrity of the material.

At the south east corner of the building the foundation wall has settled slightly, and at the northwestern corner of the portico, foundation bricks have fallen away and the foundation is no longer supporting this corner of the building.

1. Paint on entire east side of Main Building is peeling, apparently due to rainwater runoff from the roof running down the face. With the exception of this side of the building, wood trim and clapboards appear to be in adequate physical condition for refinishing once dry.

2. A portion of the east side of the Main Building clapboards, between the third and fourth windows from the south, around sill height, are displaced outward. We believe that this may be the result of warm damp air rising in the interior heating duct shafts located on this wall (which may not be lined), migrating to the exterior by air pressure, and condensing on the inside surface of the clapboards. In sub-zero weather this would freeze and expand, causing the displacement we observe on the exterior. Without the ability to see inside these shafts it is not certain that this is the cause, but it seems likely given the wet conditions in mechanical room 2 and the general dampness of the basement crawlspace that this system is open to. This condition needs to be addressed promptly to avoid further deterioration.

Rainwater damage caused by water falling directly from the Main Building roof eave, or through downspouts that deposit gutter runoff directly against the building, needs to be corrected so that rain water is either collected or directed away from the building's foundations (see gutter and downspout section following for details).

Once the roof rainwater runoff problems are resolved, the foundations need to have paint coatings removed, brick repaired where damaged, and repointed throughout.

1. East: large portions of this side of the Main Building are peeling and should be scraped and prepared for repainting. The areas where clapboards are bulging out should be investigated for causes and repaired as feasible. This may entail interior renovations to the heating duct shafts on this exterior wall
